NASA CR-72288  
GDC-DBG 67-002

## WELDMENT FLAW GROWTH CHARACTERISTICS OF 2219-T81 ALUMINUM ALLOY

by  
W. E. Witzell and C. J. Kropp

FINAL REPORT

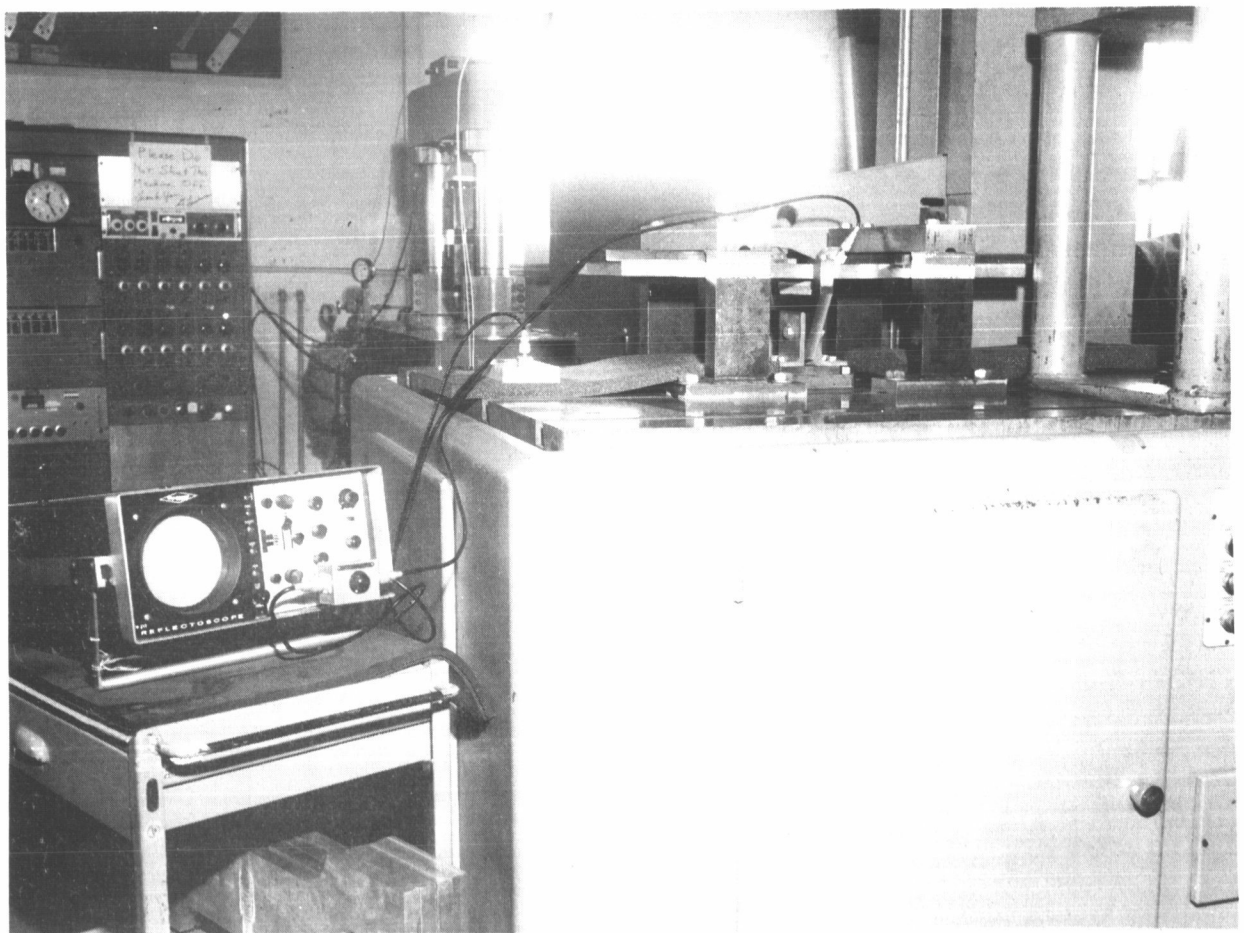
Figure I-5. Ultrasonic Test Instrumentation Used During Cyclic Flaw Enlargement on the One-Inch-Thick Plate Specimens
